Project Piglet 2022-23

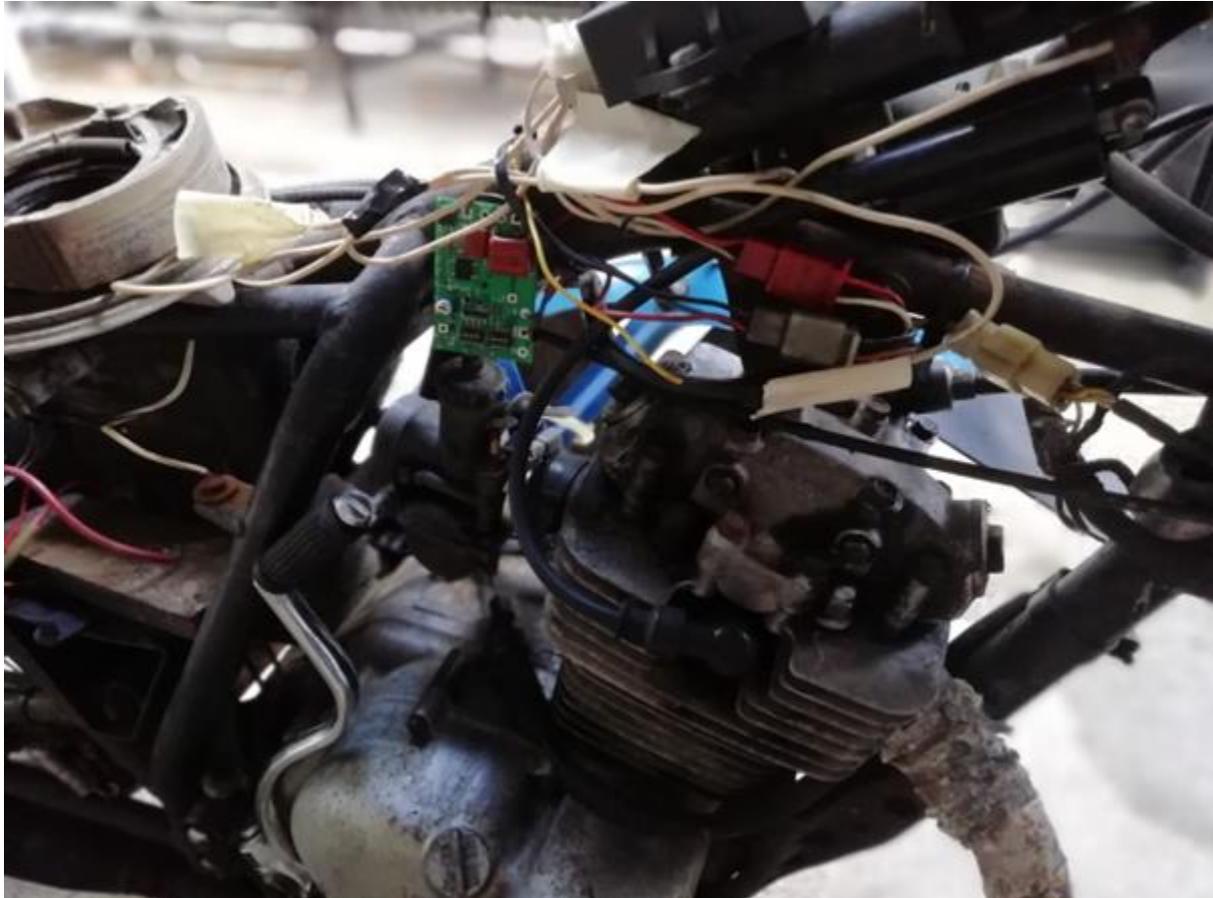
Tom was able to identify some issues with our bike, some connections that weren't connected correctly, and also that the CDI unit had been bypassed, as someone had tried to insert an alternative one (see the spare circuit board in the picture below).

To fix it we will have to replace the CDI unit, remove all the wiring for the bypass then follow the wiring to make sure all the wires go to the correct place. You can see the bird's nest below!

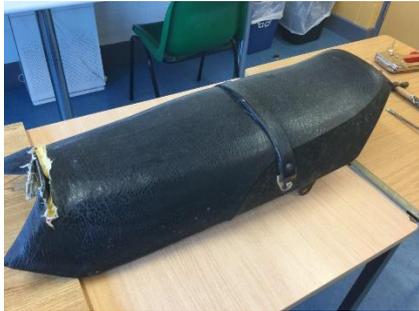
We came in from the cold. The aim was to take the old split cover off the seat and replace it with a new one. Some time was lost in sourcing tools, but we managed to get the old cover off. This revealed that the cover was a replacement itself, installed over the original.

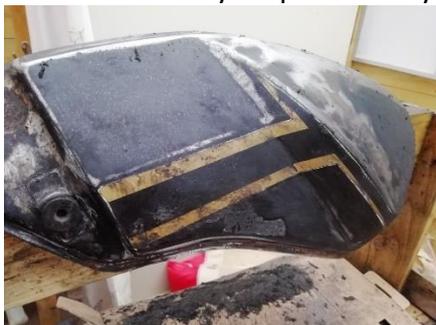
Interestingly, when sanded, the tank appeared to be originally black, with gold stripes (a bit like the John Player Special livery in the 70's /80's).

The log book gives the colour of the bike as being blue, so this is not the original tank for the bike. Maybe the original was damaged or sprung a leak or got rusty inside.

Over the Christmas period the petrol tank was sanded down so it can be primed it for painting.

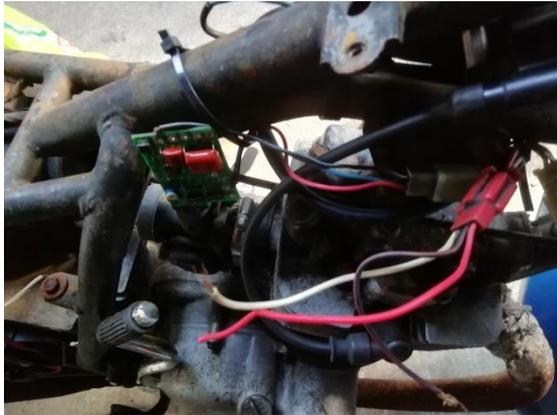
The spurious wiring was removed, leaving a jumble of wires that had no obvious way to be connected to the CDI.

Rather than the 3 wires from the stator that were expected, there were 6 wires in two groups. In the photo above you can see the red connector and clear connector on the right, each with 3 wires emerging. This was very puzzling as there seemed no way to match up the wires to the CDI. However, on researching the problem the picture below was found, showing a different CDI with two connection points. Now the wiring makes sense, we just have the wrong CDI (I hope the suppliers take it back!) The former owner has cut off the connectors/plugs that would have entered the CDI, leaving the 6 wires exposed and no easy way to figure out which wire goes where.
