Project Piglet 2022-23

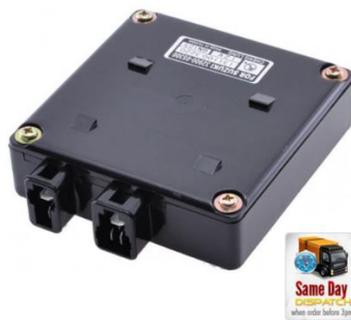
Rather than the 3 wires from the stator that were expected, there were 6 wires in two groups. In the photo above you can see the red connector and clear connector on the right, each with 3 wires emerging. This was very puzzling as there seemed no way to match up the wires to the CDI. However, on researching the problem the picture below was found, showing a different CDI with two connection points. Now the wiring makes sense, we just have the wrong CDI (I hope the suppliers take it back!) The former owner has cut off the connectors/plugs that would have entered the CDI, leaving the 6 wires exposed and no easy way to figure out which wire goes where.

The next jobs to do are to order the new CDI, change the oil and filter (the sump plug has now been loosened to allow this to happen), to prime and paint the fuel tank and front mudguard, and to source and drill brackets for the new indicators.
